Operation **TEAPOT**

Project 31.2

**DAMAGE TO COMMERCIAL AND INDUSTRIAL BUILDINGS
EXPOSED TO NUCLEAR EFFECTS**

Report to the Test Director

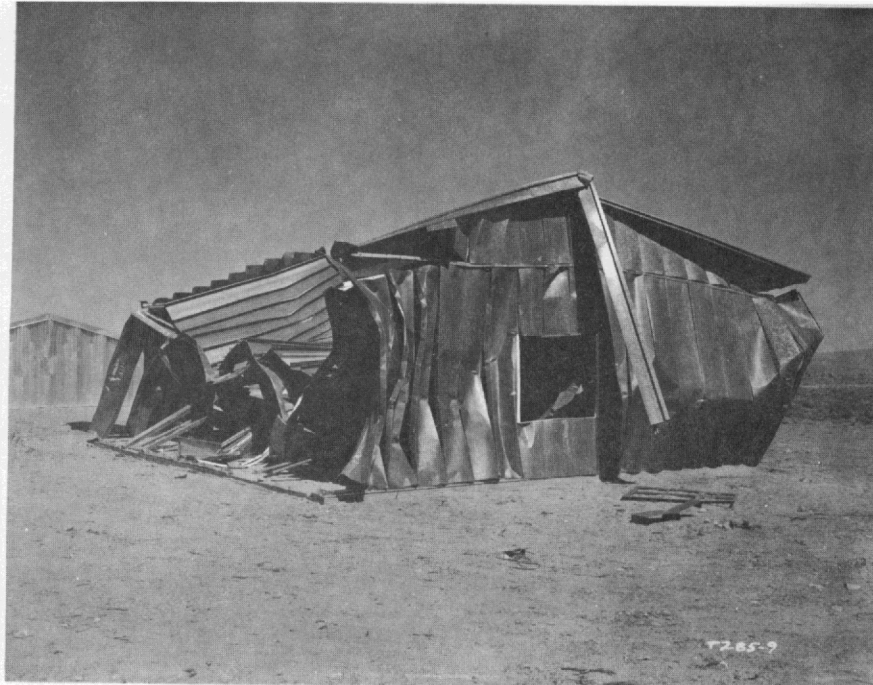
Fig. 2.38 — West end of Armco Building 31.2-d1 after planned test.

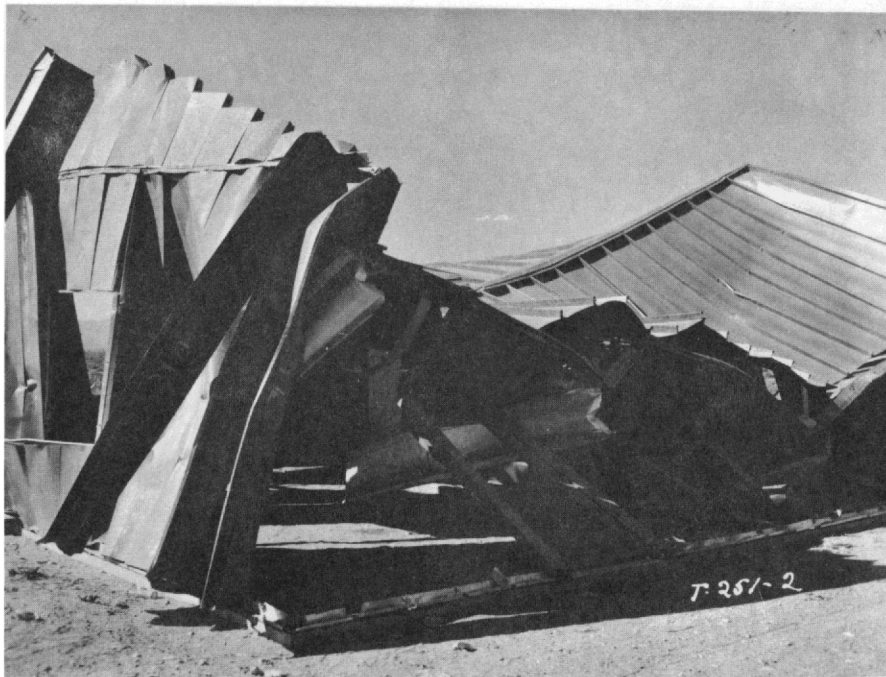
Fig. 2.39 — Northeast corner of Armco Building 31.2-d1 after planned test.

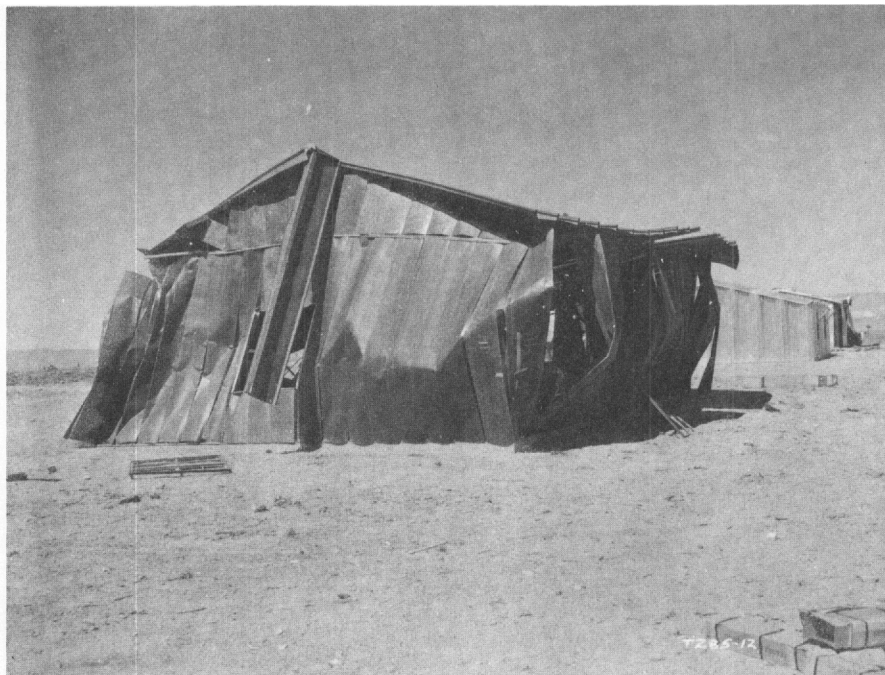
Fig. 2.40 — West end and south side of Armco Building 31.2-d1 after planned test.

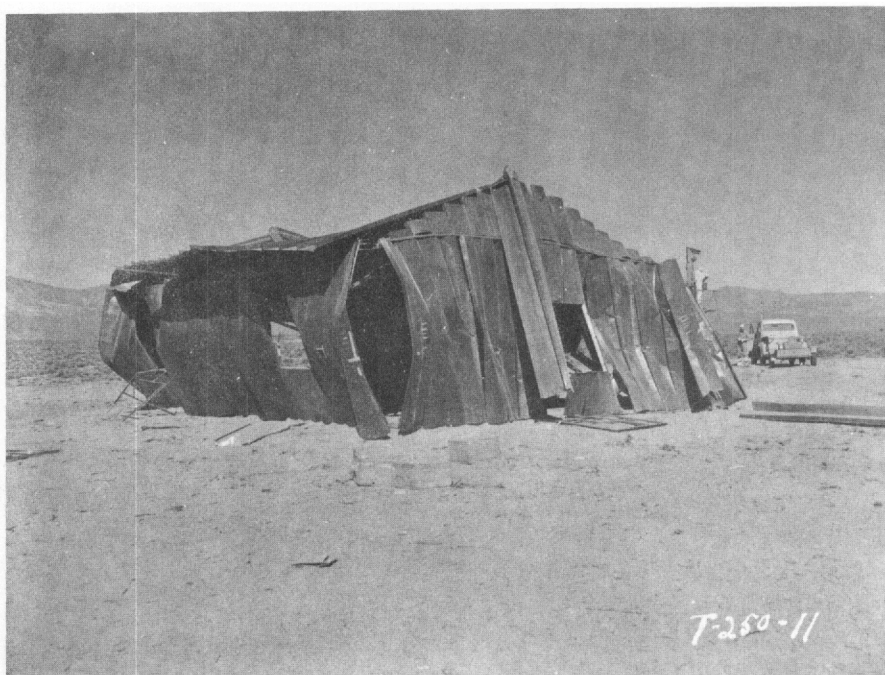
Fig. 2.41 — East end and south side of Armco Building 31.2-d1 after planned test.

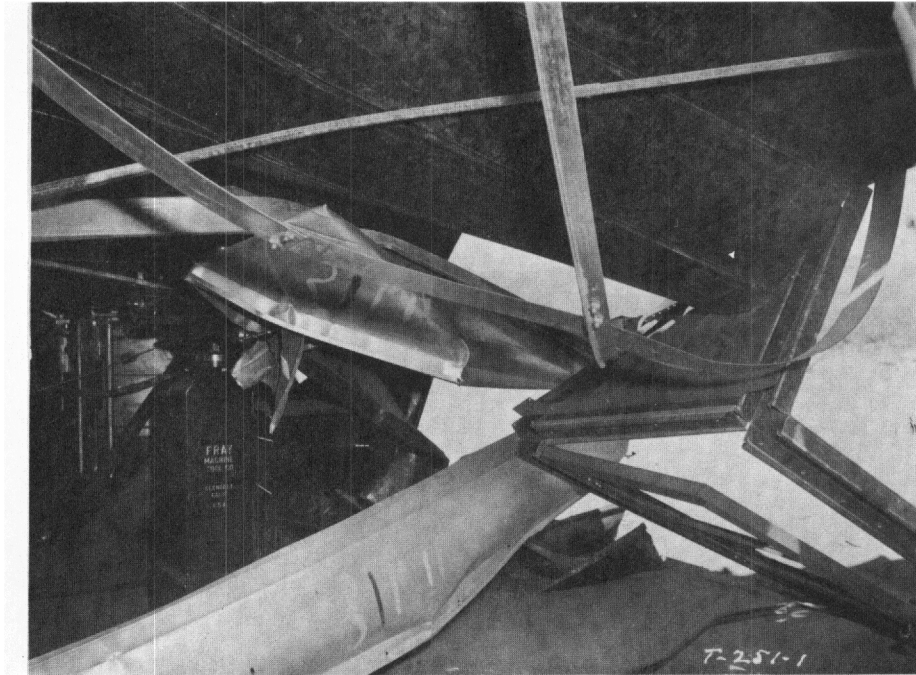
Fig. 2.44—Interior view toward northeast door frame of Armco Building 31.2-d1 after planned test.

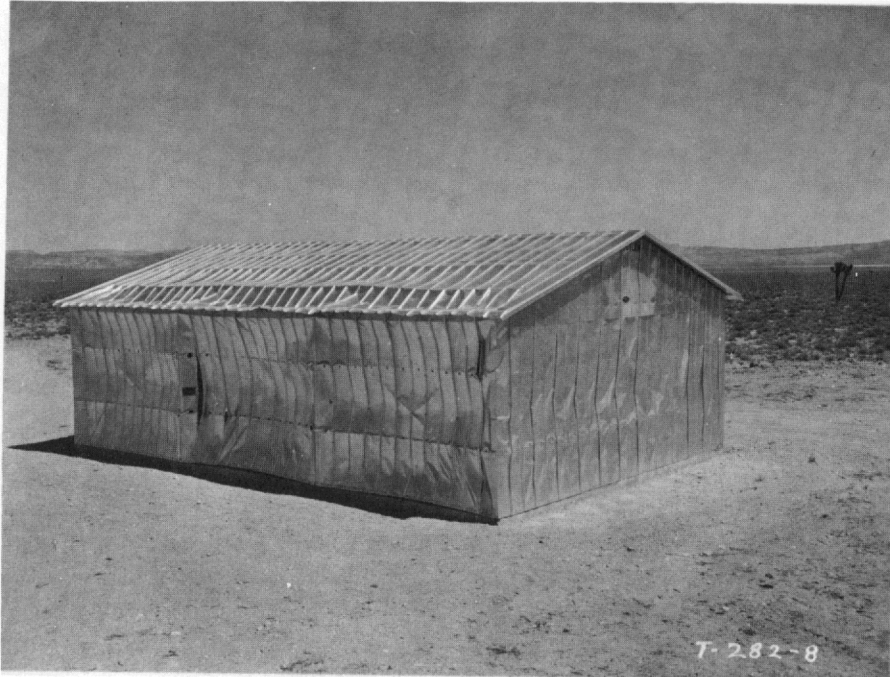
Fig. 2.46 — North side and west end of Reynolds-Butler Building 31.2-a2 after planned test.

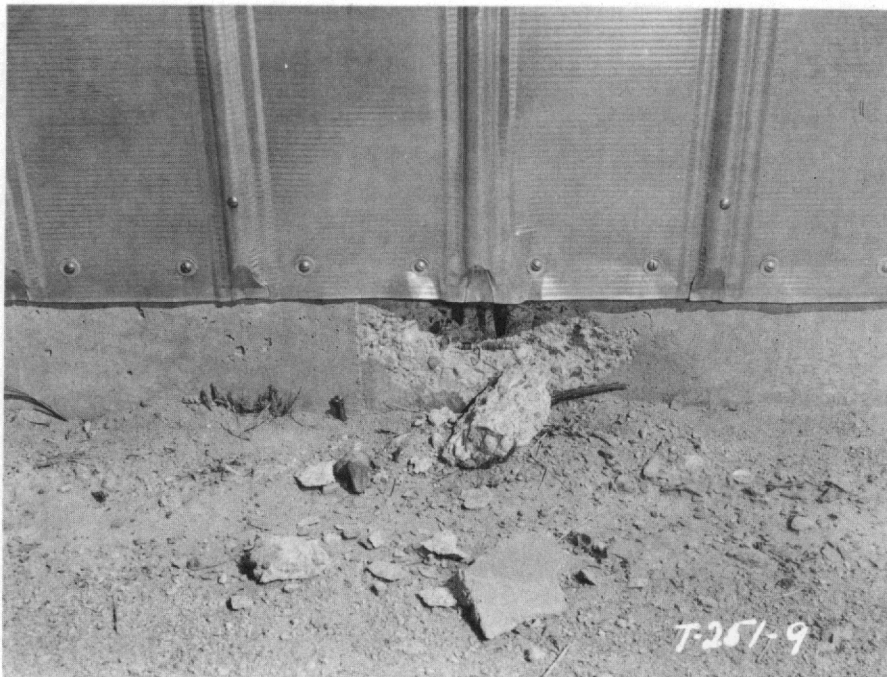
Fig. 2.47 — South side of east interior column footing of Reynolds-Butler Building 31.2-a2 after planned test.

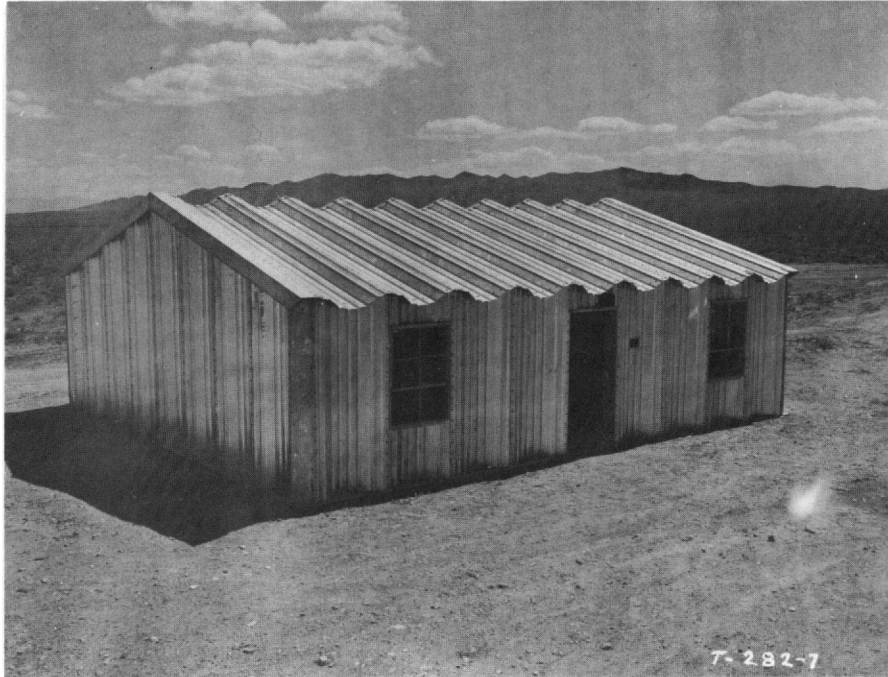
Fig. 2.50 — East end and north side of Behlen Building 31.2-b2 after planned test.

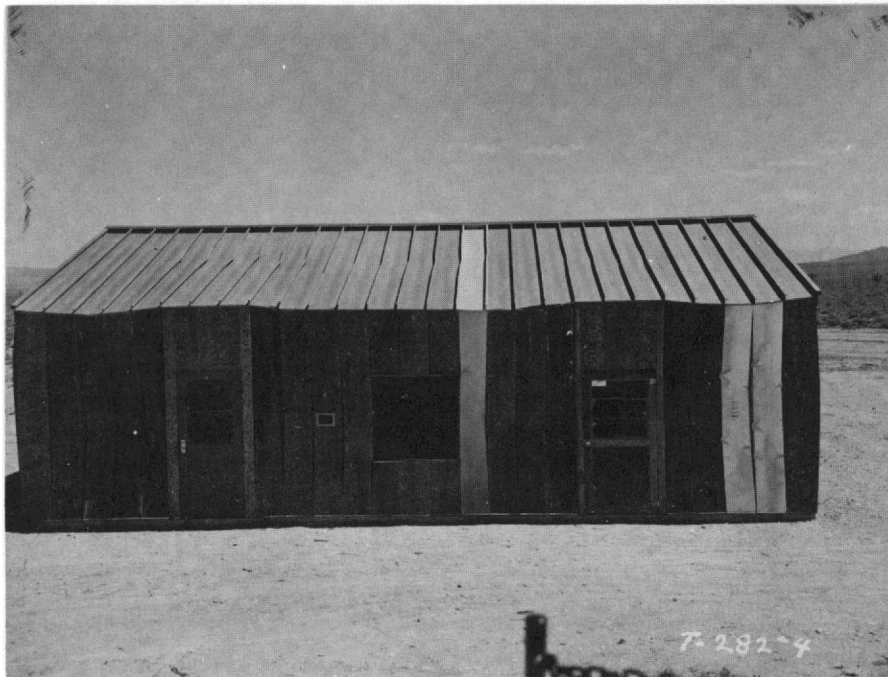
Fig. 2.51 — North side of Armco Building 31.2-d2 after planned test.

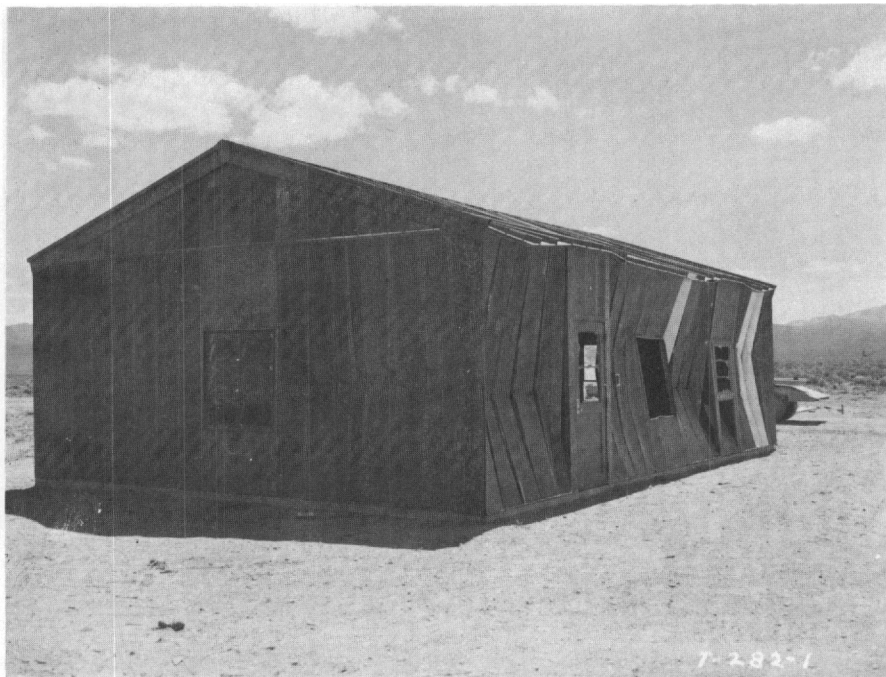
Fig. 2.52—East end and north side of Armco Building 31.2-d2 after planned test.

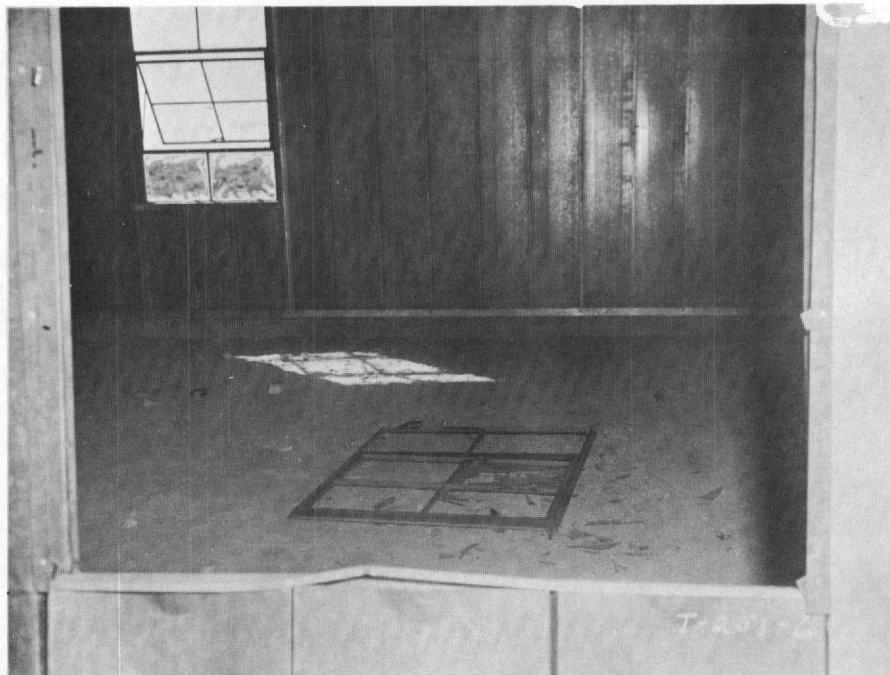
Fig. 2.53—View looking south into interior of Armco Building 31.2-d2 after planned test.
